CRI  
TECHNOLOGY  
DIGEST

TD-1

## **CHEMICAL ATTACK OF REINFORCED CONCRETE STRUCTURES – CRI EXPERTISE FOR DIAGNOSIS AND PREVENTION/PROTECTION**

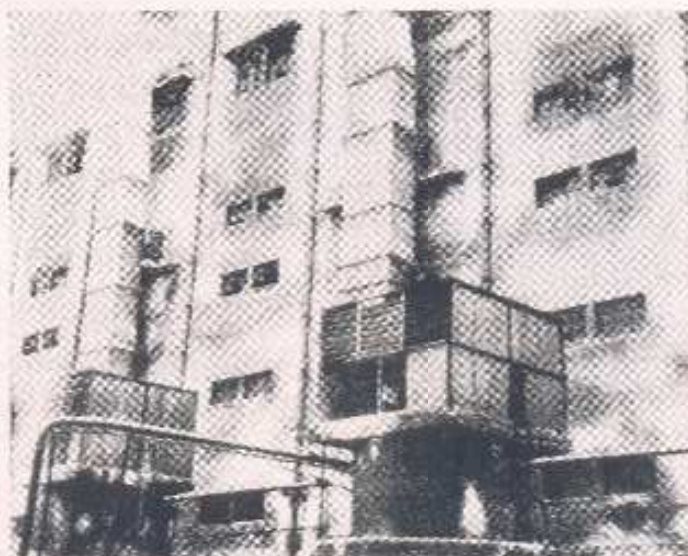
Fig. 1 Exterior walls with discoloured patches

Many a time, the effect of the reaction may not be immediately evident, though there may be occasional tell-tale signs, such as surface discolouration (Fig 1), spots and efflorescence on finishes (Fig. 2), and failure of external renderings and finishes (Fig. 3). This is because the reaction is generally slow. However, eventually the

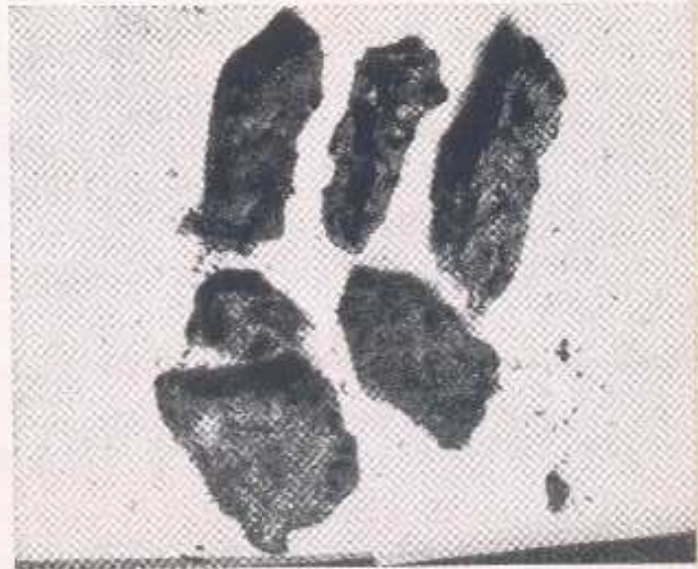
*Fig. 5 Disintegrated pieces of concrete*

ted by aggressive agents/environment, though to different extents. The deterioration could be broadly divided into three degrees. The least severe one was characterized by appearance of spots on finishes, discolouration, failure of external renderings and finishes, decorative and/or protective finishes. The more severe one meant cracking, progressive reduction in strength and stability of structural units like bricks and reinforced concrete beams, columns, roof and floor slabs. The most severe one was typified by cracking and spalling of concrete cover over steel reinforcement (Fig. 4), reduction in reinforcement section, rusting of reinforcement, and disintegration of concrete (Fig. 5), by dissolution of cementing matrix.

**Protection** — The protective measures suggested included overdimensioning, application of protective coatings and paints from a wide range, and use of acid-resisting ceramic and plastic tiles and acid-resisting bricks as lining or floor finishes. Among the preventive measures, emphasis was placed on control of CAN dust emission, such as through improvement in dust collection and effective venting off of the dust. Also, precautions were indicated to stop leakages of reactants and reaction products to the extent practicable. Repair techniques were suggested for portions with deteriorated concrete; the techniques were such as not to require shutting down of the plant.
