National Council for Cement and Building Materials

ALKALI-AGGREGATE
REACTIONS IN CONCRETE :
CAUSES, DIAGNOSIS AND
PREVENTION

PART I

NCB
TECHNOLOGY
 DIGEST

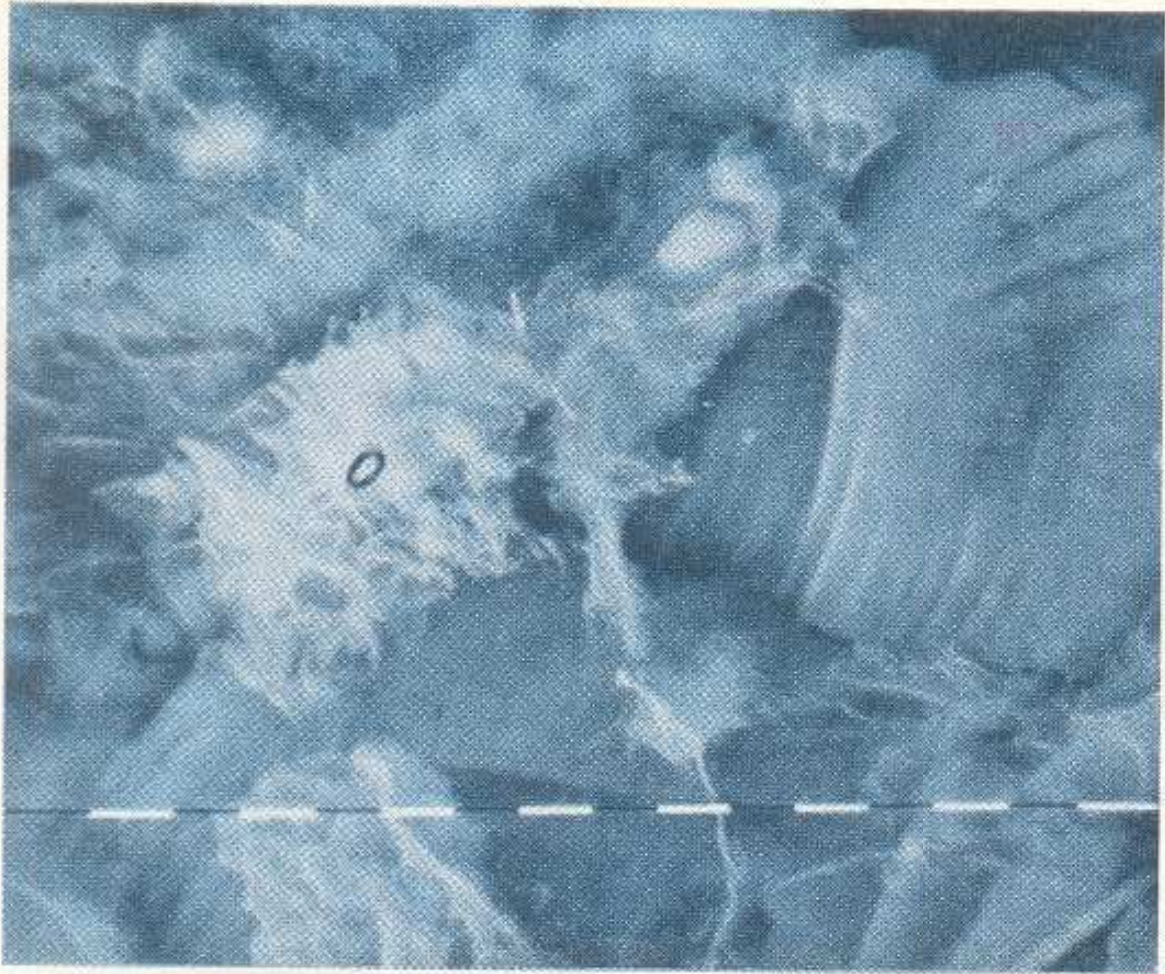
Fig 1 Scanning Electron Micrograph of an aggregate treated in KOH

While detection of potential alkali-reactivity of aggregates containing cryptocrystalline silica minerals is somewhat straightforward, eg, by rapid chemical test or mortar-bar test, those due to presence of strained quartz pose some problem. In such cases rapid chemical test may not detect the reactivity, and that threshold values for mortar-bar tests may have to be somewhat lowered. Comprehensive investigation at NCB has led to methods for characterisation of such reactive aggregates containing strained quartz, through comparison with the established test procedures as well as use of infra-red spectroscopy and scanning electron microscopy (Fig 1) with the energy dispersive analysis of X-rays. These methods are being applied in case of concrete dams to be constructed in future.

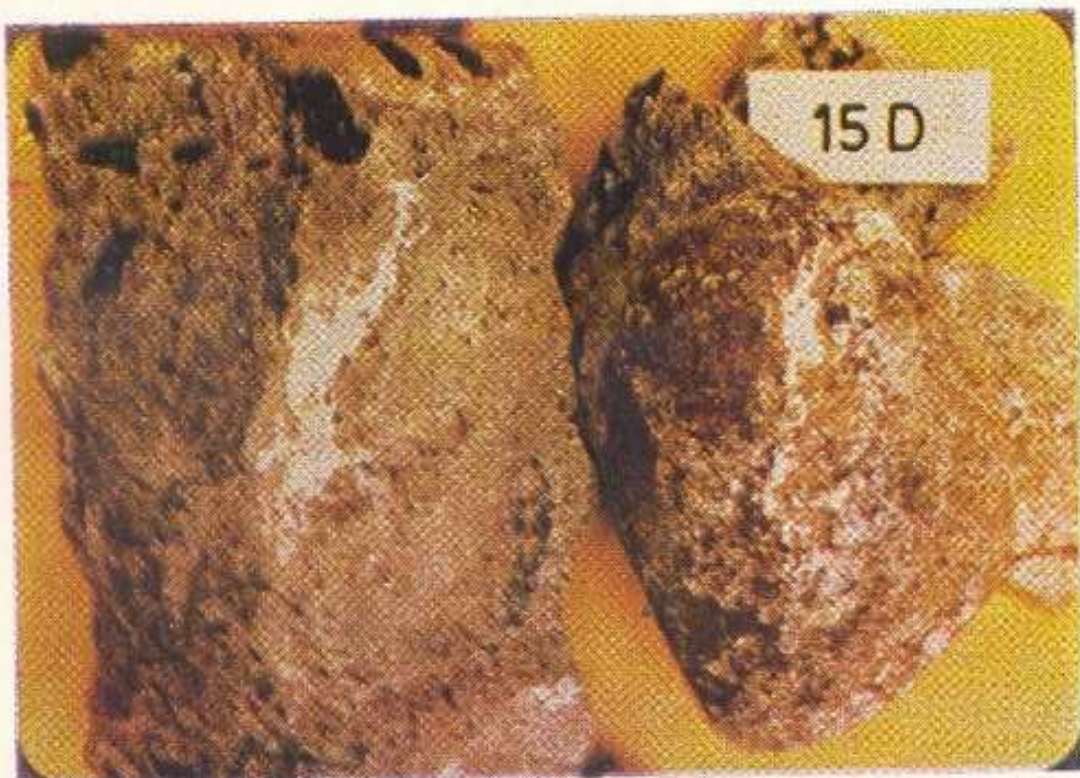
Fig 2 Gel formation on the aggregate

a) Presence of gel as a most abundant and conspicuous deposit in voids and cracks inside the concrete (Fig 2) and sometimes as exuding out of it. This gel has been described as "white and porcelain-like in texture, or usually translucent and bluish white or dull opaque white, rubbery to powdery to brittle", etc;

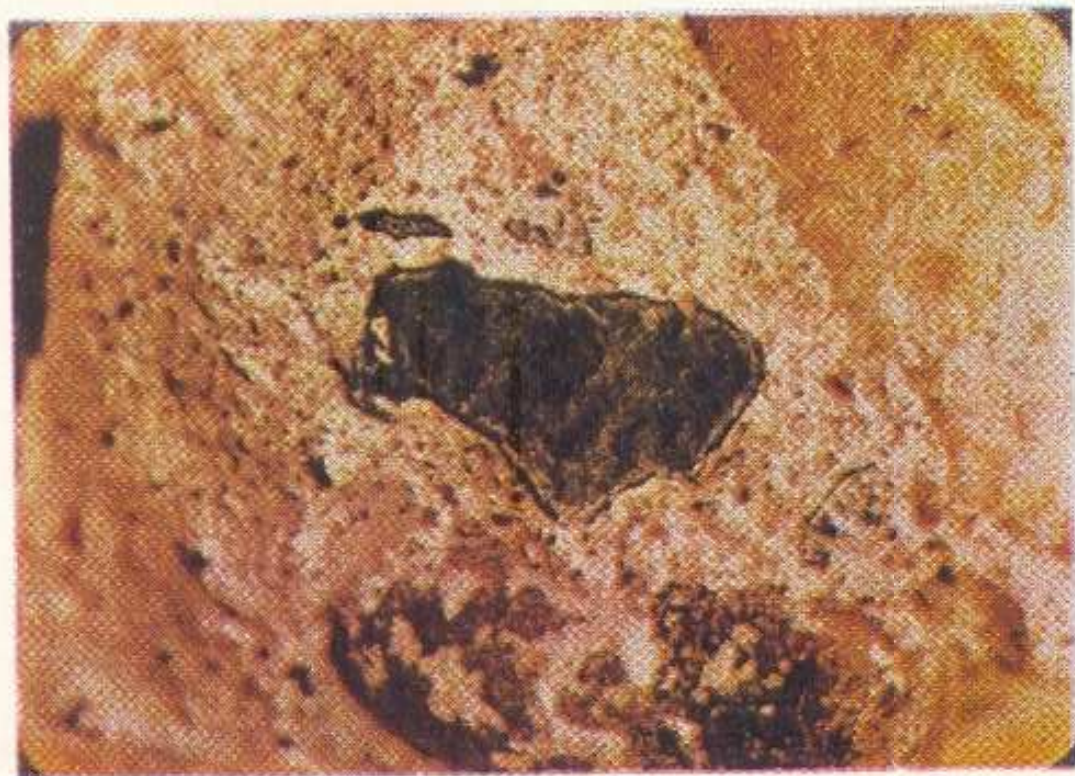
Fig 3 Dark reaction rims on aggregate

b) Presence of aggregate alteration borders along with dark reaction rims (Fig 3) and dark borders visible under low magnification; and

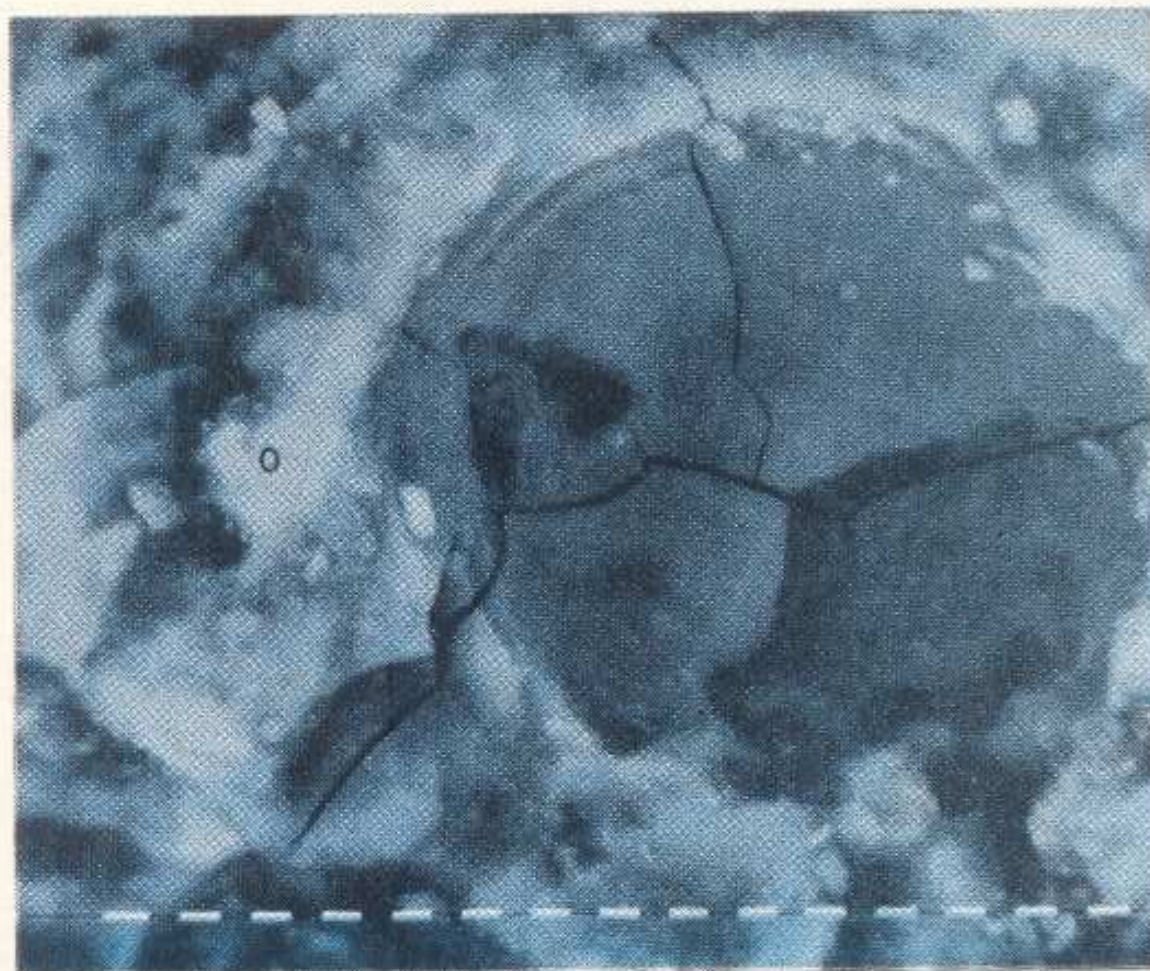
Fig 4 Scanning Electron Micrograph of gel formation around a cavity occupied by an aggregate and microcracks on the mortar phase

Among the methods employed to detect the presence of ASR in in-situ concrete structures are optical microscopy, chemical analysis including flame photometry, infra-red spectroscopy, X-ray diffraction, electron microscopy (Fig 4) and others. Rapid chemical test for detection of ASR as per ASTM-C-289 or IS : 2368 on selective aggregates extracted from the concrete has also reported. Generally some or the other of these techniques have been used in investigations of ASR by various agencies. However, NCB is uniquely equipped with all the above diagnostic facilities.
