CRI TECHNOLOGY DIGEST

NON-DESTRUCTIVE TESTING OF CONCRETE

Part 2

February 1982

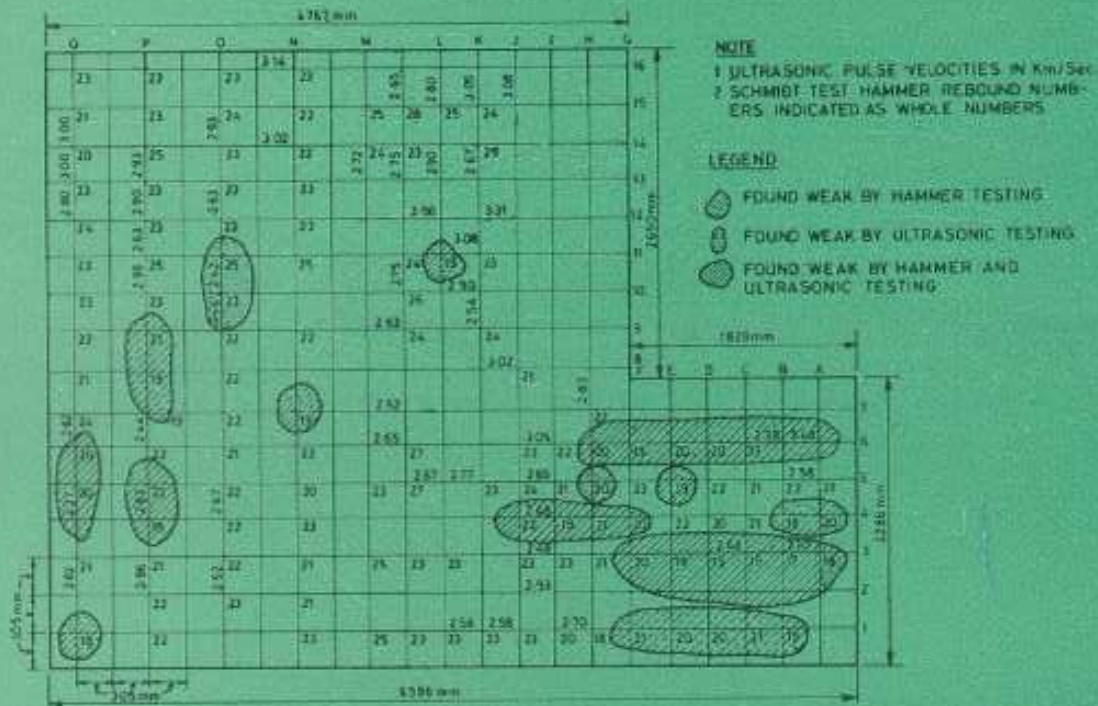
The RCC raft foundation of a tower structure in a fertiliser plant 5·0 x 6·6 metres in plan was investigated to assess the overall quality and likely compressive strength of concrete. By the combined use of UPV and rebound hammer methods, the compressive strength of concrete was assessed to be of the order of 100 kg/cm^2 which was much lower than M20 grade specified. The entire foundation area was categorised in terms of its overall quality and compressive strength (Fig 1). The results were further corroborated by subsequent laboratory tests on the cement and concrete samples made with the material and mix proportions adopted in the works. Suitable remedial solutions were thereafter adopted.

Fig 1 Assessment of overall quality of concrete in an RCC raft foundation

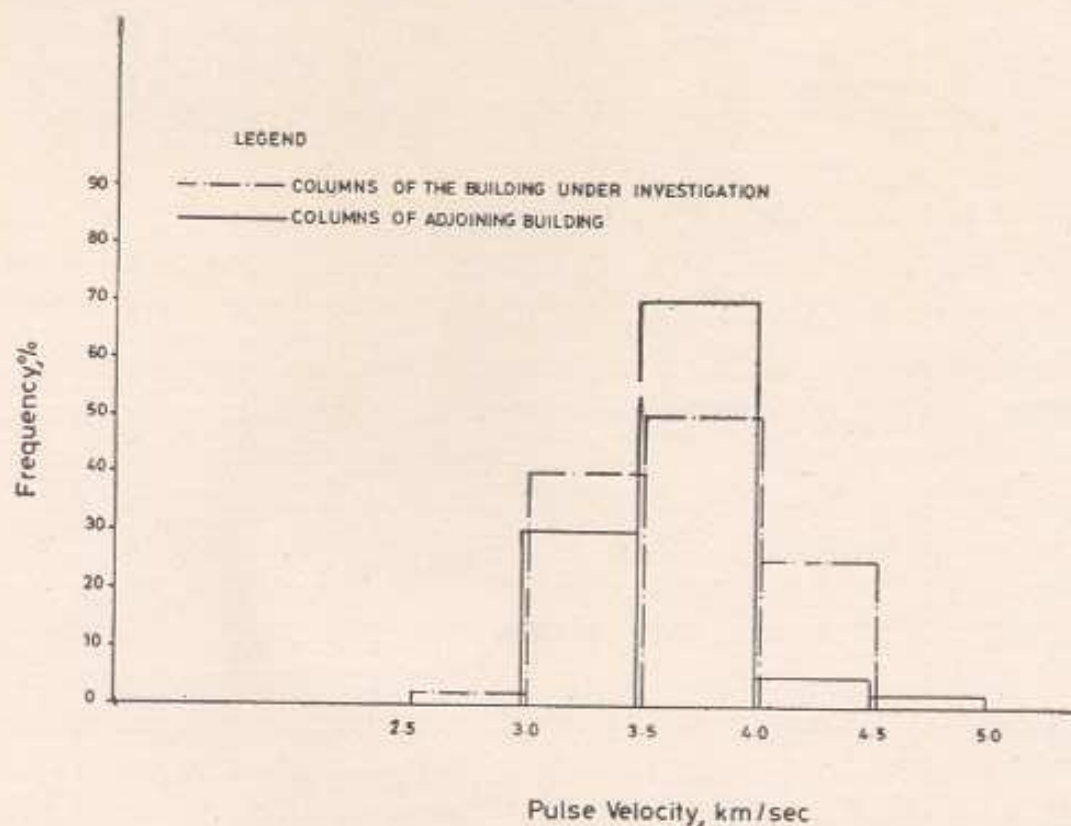
country were assessed for their structural adequacy to carry the loads of additional two storeys proposed to be added nearly 15 years after the original construction. Although the rebound hammer indices were satisfactory, the UPV values were found to be generally lower than those encountered for similar grades of concrete in India. The overall condition of the structure was satisfactory and no signs of distress due to load or weathering were noticed. In absence of records of the original materials (specifically aggregates), mix proportions and level of workmanship obtainable at the time of construction, comparative tests were done on the ground floor columns of an adjacent five storey block constructed to similar specifications by the same agency at the same time. A comparison of histograms of the rebound hammer indices and pulse velocity values (Fig 2) led to the conclusion that concrete in ground floor columns of both the buildings was more or less of similar quality except a few columns which were of suspect quality. Analysis of cement content in columns chosen at random from both the buildings gave comparable values. It led to the conclusion that additional two storeys can be added on the building after strengthening the suspected columns.

Fig 2 *Comparison of pulse velocities in R C C Columns*

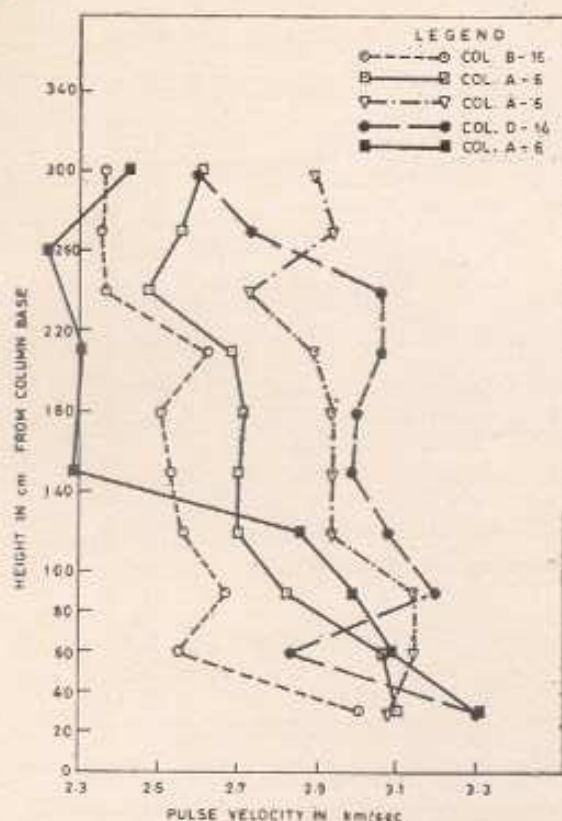
three-storey RCC frame structure were assessed by the UPV method where the columns had developed severe corrosion cracks within a short time after its construction. Variation in UPV along the height of the columns showed that the concreting was not uniform (Fig 3). This conclusion was corroborated by further testing of cement content, pH value and chloride and sulphate contents of the concrete samples obtained from different portions of the columns as well as considerable segregation noticed when the outer mosaic dado was removed. The overall quality of concrete in the columns was assessed to be ranging from 'poor, to 'questionable'. Along with other possible causes, such variation in the quality of concrete may itself give rise to corrosion cells.

Fig 3 Variation of pulse velocity along the height of columns

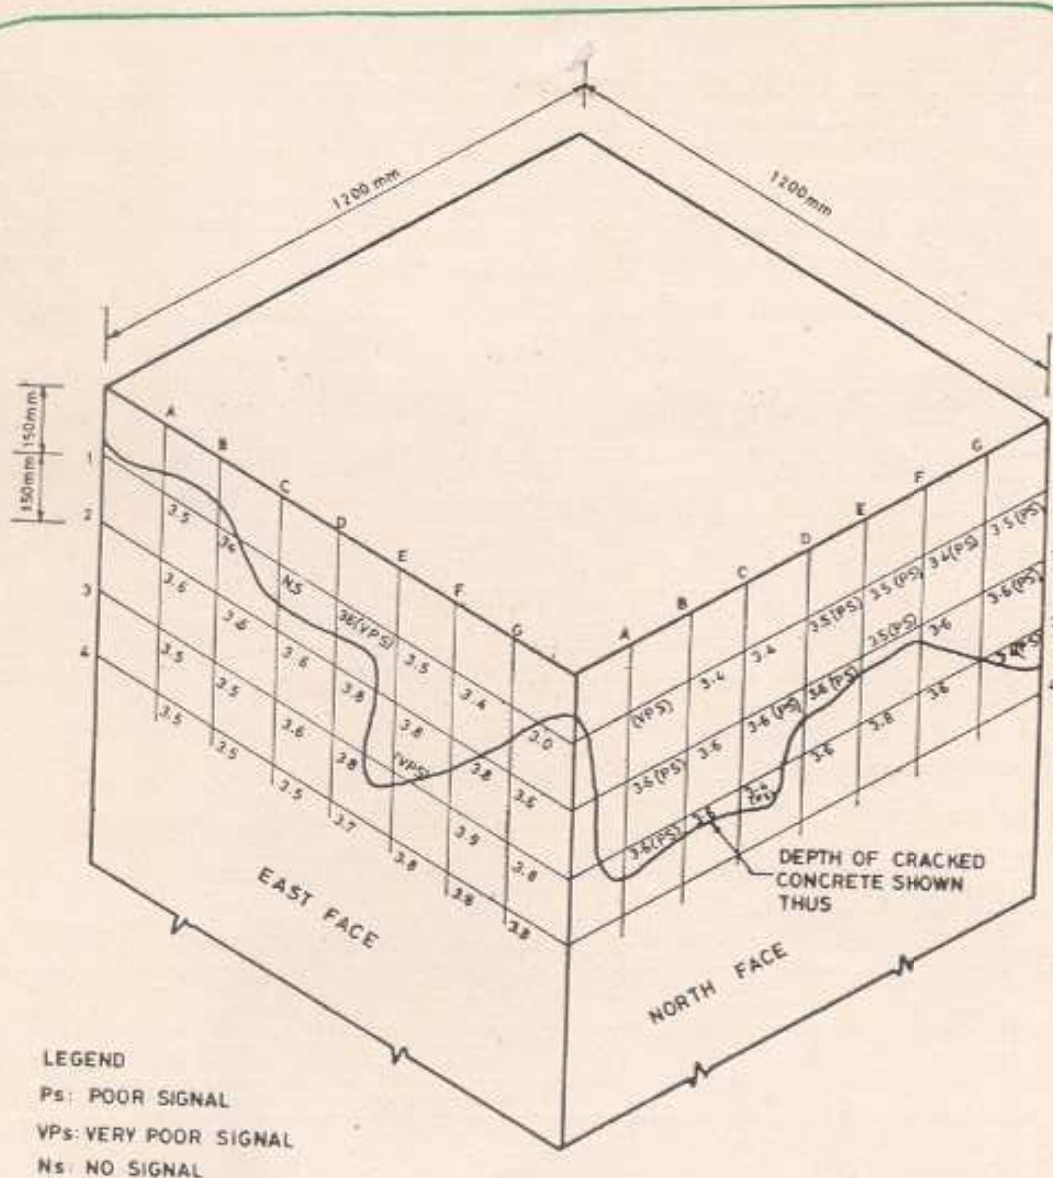
The horton sphere foundation of a fertiliser plant was damaged during construction as a derrick fell suddenly on the pedestals. There were some visible cracks on the top surface and it was suspected that cracks had penetrated inside to various depths. The extent of damage to pedestals was investigated by UPV method. On comparison of the UPV values obtained within different portions of the affected pedestals as well as on other pedestals which were not affected, the depth of cracks could

be assessed as shown in Fig. 4. During reconstruction of these foundations, the depth of cracks so assessed was found to be close to the actual.

Fig 4 Depth of crack in concrete pedestal as assessed by ultrasonic pulse velocity measurement
